# SuperTrak CONVEYANCE™ Application Note

## Controller Software 3.0.54.0 Boundary Upgrade

ST3-AN-22#-V1

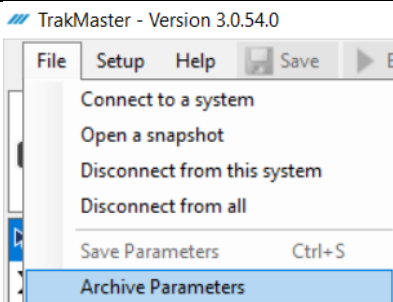
STEP	GRAPHIC/INSTRUCTION
1. Create an archive of the current configuration

<p>TrakMaster - Version 3.0.54.0</p> <p>File Setup Help Save ▶ E</p> <p>Connect to a system</p> <p>Open a snapshot</p> <p>Disconnect from this system</p> <p>Disconnect from all</p> <p>Save Parameters Ctrl+S</p> <p>Archive Parameters</p>

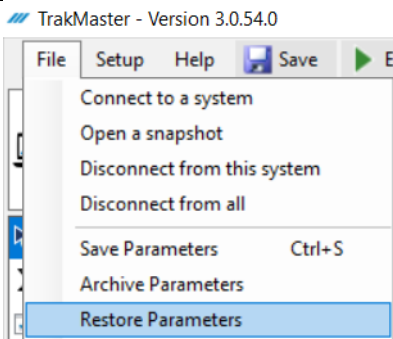
3. Restore the archive created in step 1

<p>TrakMaster - Version 3.0.54.0</p> <p>File Setup Help Save ▶ Er</p> <p>Connect to a system</p> <p>Open a snapshot</p> <p>Disconnect from this system</p> <p>Disconnect from all</p> <p>Save Parameters Ctrl+S</p> <p>Archive Parameters</p> <p>Restore Parameters</p>
